CENTER CITY DISTRICT  
February 1996

## TURNING ON THE LIGHTS UPSTAIRS

A Guide for Converting the Upper Floors of Older Commercial Buildings to Residential Use

Cecil Baker & Associates  
105 South 12th Street  
Philadelphia, PA 19147

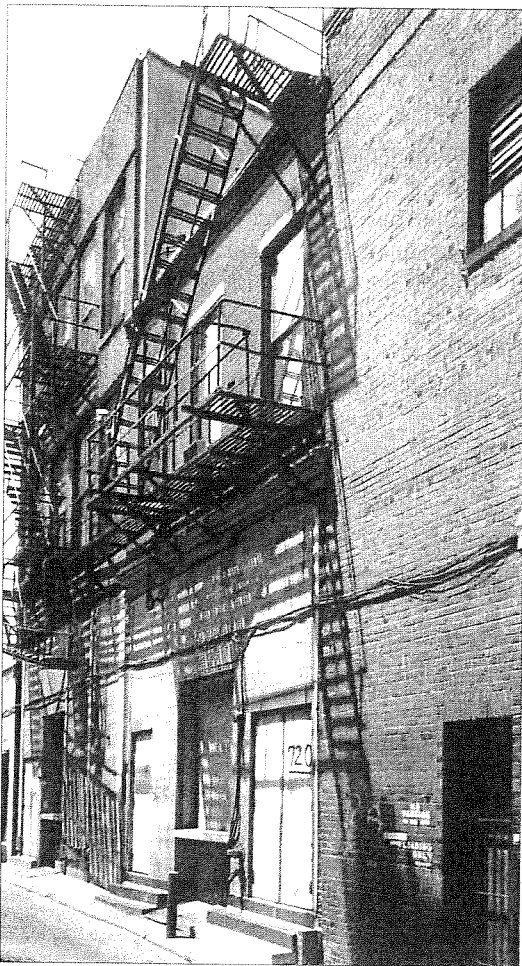
*While new fire escapes are not allowed under today's codes, existing escapes can be used to provide a code compliant exit from upper floors.*

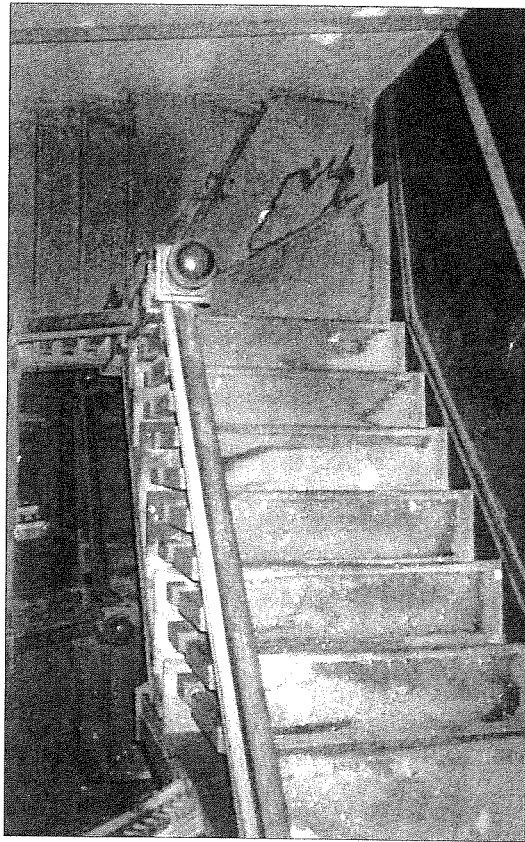
*Many older structures have narrow passages and open stairways which detract from their "safety score."*

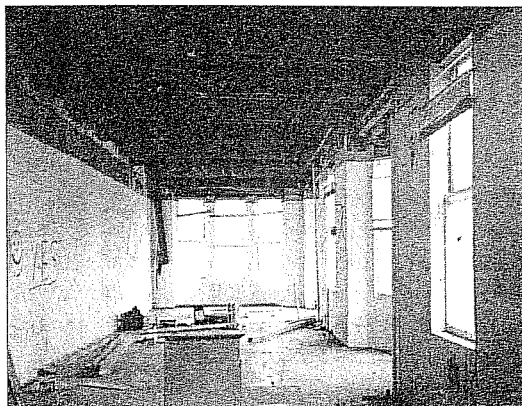
Many 1900-era structures have wood floors and ceilings. Covering these combustible structural elements with drywall can be an inexpensive way to improve the buildings “safety score.”

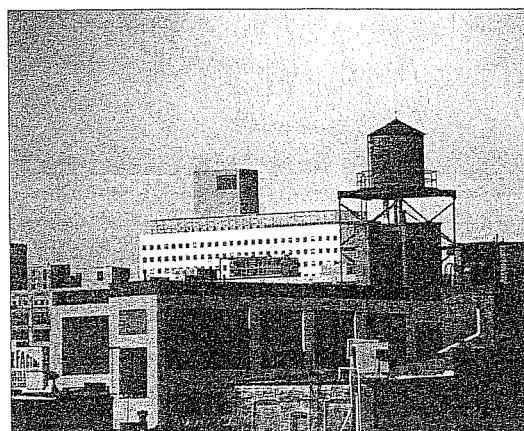
Many Center City buildings have (or once had) rooftop wood water tanks which could be used today for fire protection.

*Wood Water Tanks:* For years, wood water tanks have been used on the roofs of older buildings to supply water to standpipe systems. Gravity carries water from the tanks to risers and hoses located inside a building. The system works well as a back-up to the city water supply

and can perform even in the event of a power outage. Another advantage of the tanks is their price; rooftop water tanks could supplant the need for a fire pump, which costs between \$30,000 and \$50,000 to purchase and install. This savings is significant, especially for small buildings where the cost of the pump per square foot is particularly burdensome.

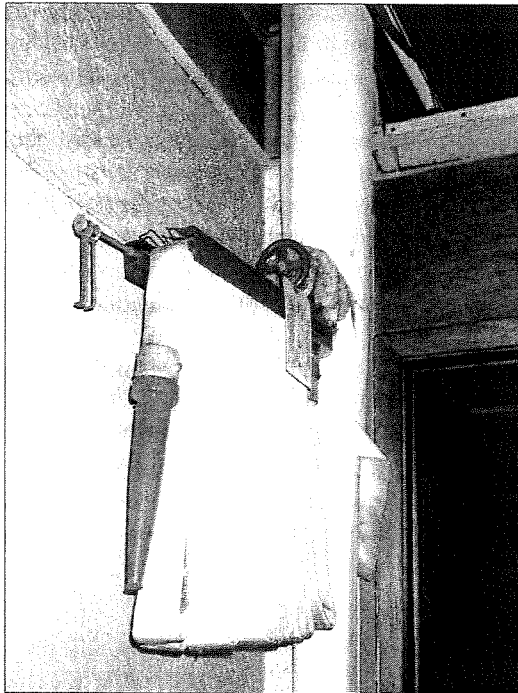
*Old fashioned standpipes can become part of new fire protection systems. Pressure from City water mains is sufficient to pump water up several stories.*

*Standpipes* are supply risers with fire hose connections at street level to permit fire trucks to provide water inside the structure in the event of a fire. At each floor, the

standpipes are equipped with fire hoses that extend the length of the building and/or with hose connections for fire department use. Existing dry standpipe systems can be converted into wet systems by hooking them up to a dependable water supply and adding sprinkler heads and piping for water distribution. The pressure from a nearby city water main may be sufficient to pump water up several stories. For taller buildings, a wood water tank could be used to provide the water supply, as long as the system *automatically* activates to put out a fire in an emergency. The use of standpipes represents a cost savings to owners to the degree existing equipment can be approved as part of a new system.

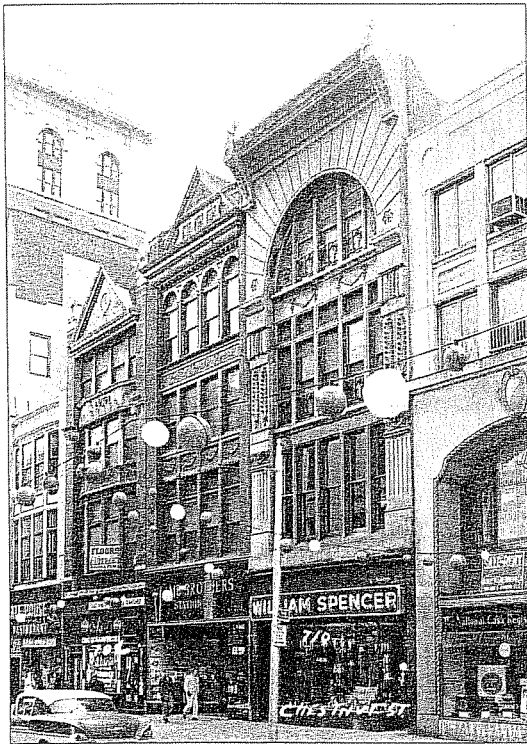
*As recently as the late 1950's, the Balderson Block in the 700 block of Chestnut Street retained its splendid architectural details. This series of buildings has been analyzed in this study as a single building, in order to test the feasibility of combining adjacent properties.*

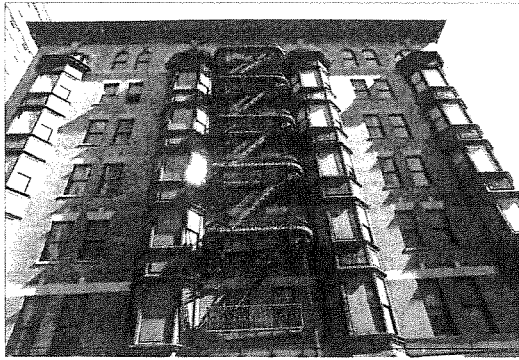
13th Street facade with fire escape

Without sprinklers, the building can achieve a passing score by repairing the existing fire escape as a second exit, adding drywall to protect the exposed wood and steel structure on all floors, providing fire resistant walls, egress lighting, and a new detector and alarm system throughout.

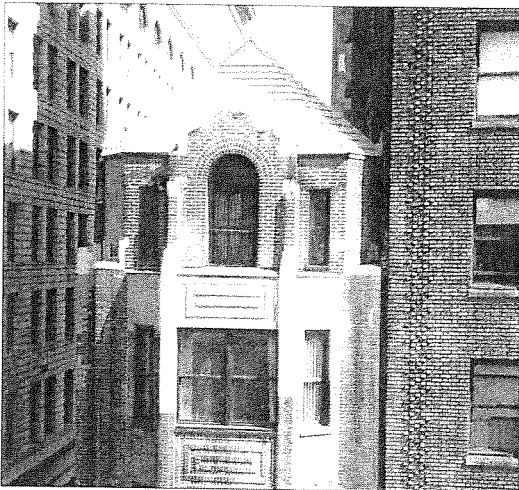
Penthouse with copper roof

Built in 1925, the Bernley Building occupies a corner site at 13th and Chestnut Streets adjacent to the Adelpia House Apartments. The ground floor has been altered with a modern storefront. Above, the original masonry and limestone-trimmed facade remains a projecting bay faced with brown brick spandrels and geometric patterning. The bay terminates with a copper gable roof.

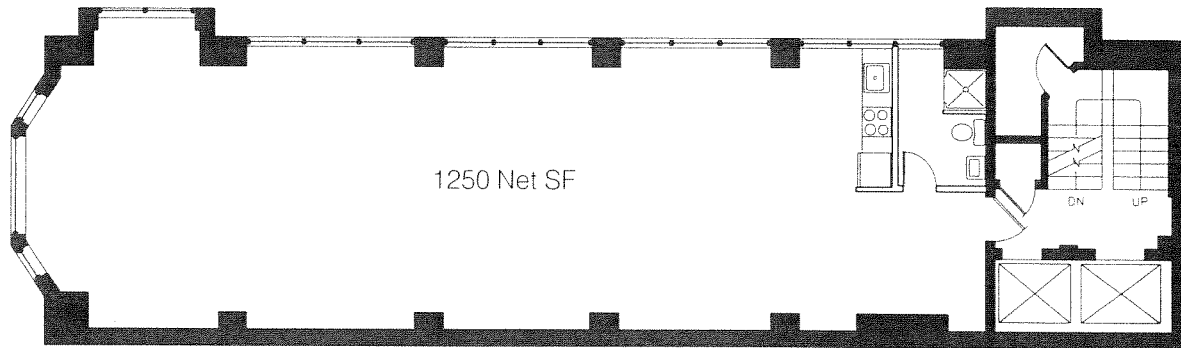
Typical Floor Plan

Yield: 7 apartments

Proposed New Use

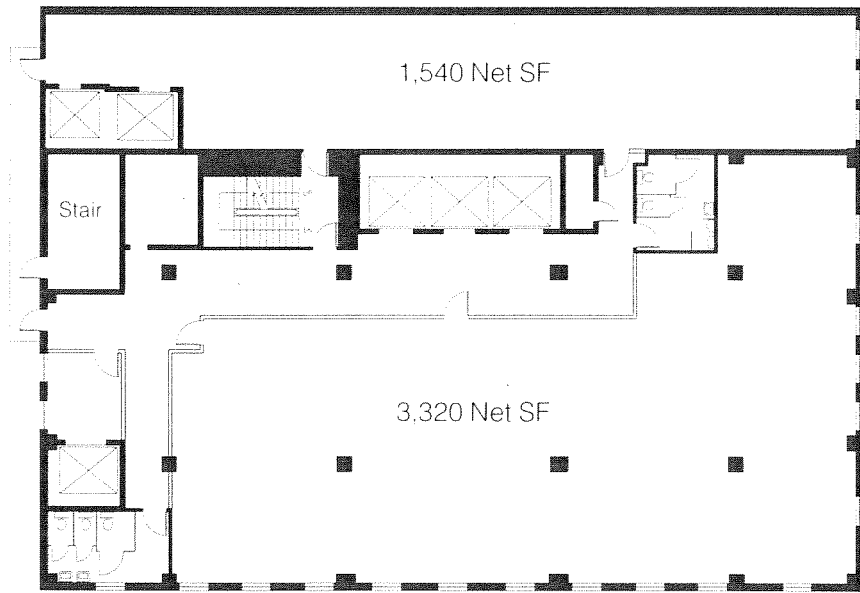
Typical Upper Floor Plan

Yield: Office occupancy, 58,000 sf

Proposed New Use

The plan on the following page shows a corridor configuration for single or multiple office tenants. In its current condition, the owner may legally use only the street level of the structure. When re-opened, the building will be evaluated by L & I using the scoring system in

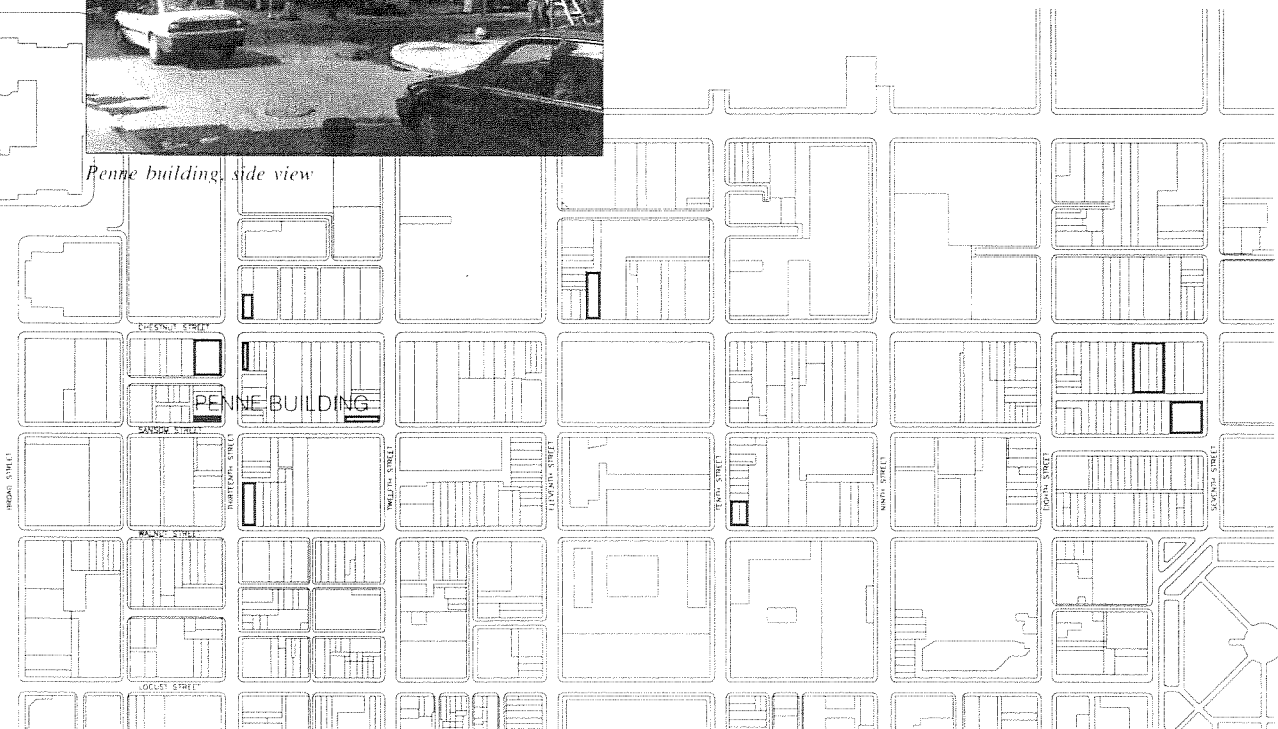
The floorplates are long and narrow with a single exit stair at one end and no fire escape. The exit stair is an example of a Philadelphia fire tower common to buildings from the first quarter of the 20th century. The tower includes an exterior balcony to provide an alternate entry to the stairwell from outside the building. While the floor plan is

inefficient for modern offices, the building could work well for apartments. Each of the upper floors would contain a single unit with four large bay windows, evenly flooded with southern light.

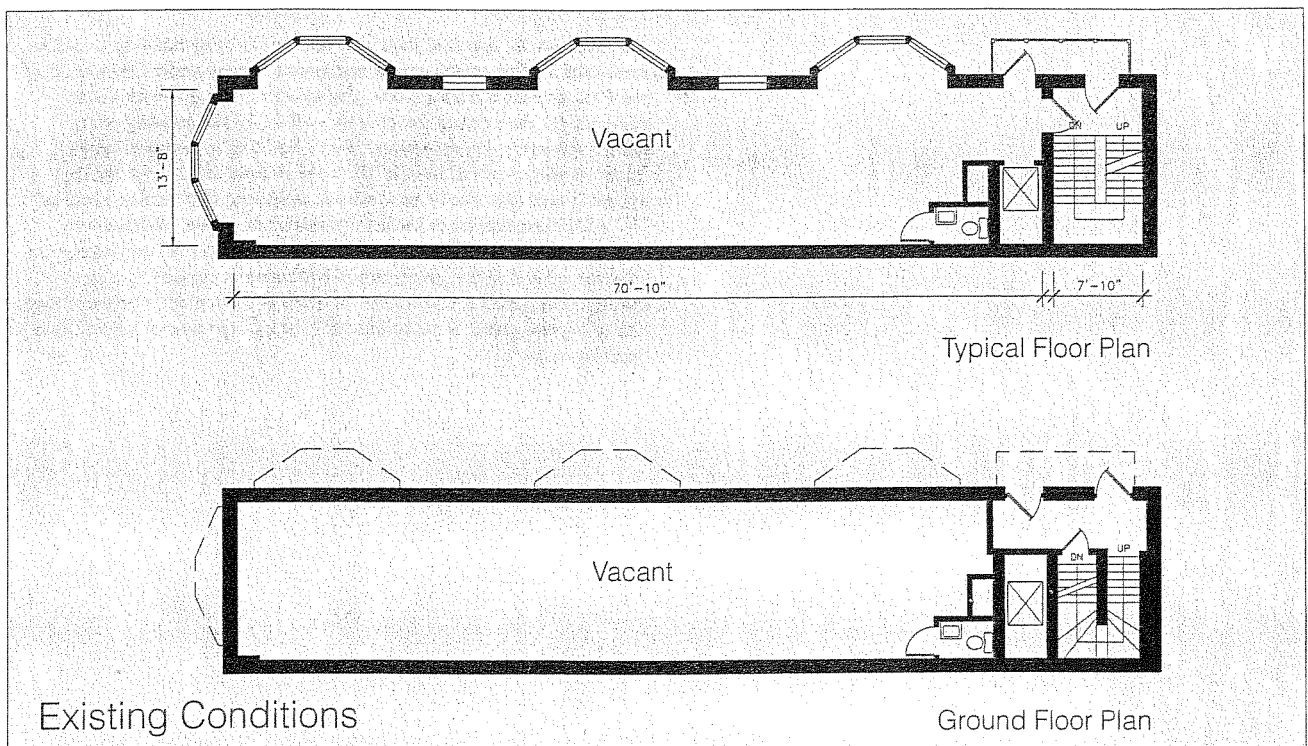
Yield: 5 apartments

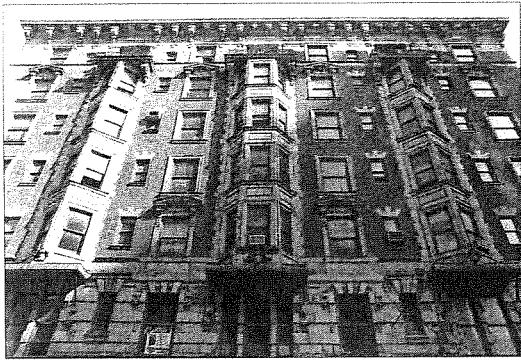
*13th Street façade with terra cotta trim*

Over time the building has been converted from a hotel to offices for small businesses. Outside, the structure appears somewhat worn, but is in relatively good condition. Most of the terra cotta trim is in place, although some ornamental pieces are missing from beneath the balconies and cornice. The exterior brickwork and trim need to be painted and repaired soon to prevent further damage.

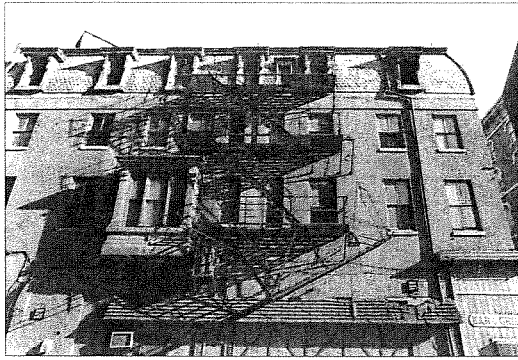
*Sansom street façade showing mansard roof*

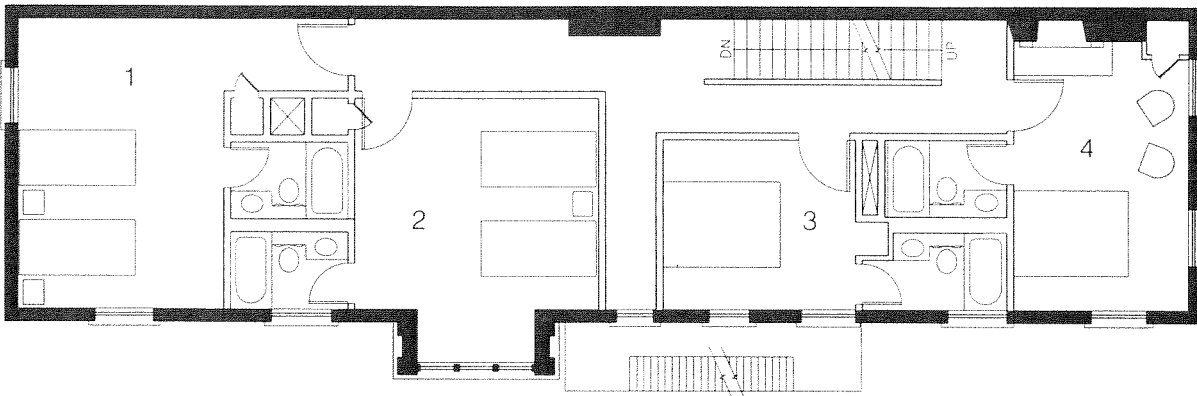
**Typical Floor Plan**  
**4 Rooms**

Proposed New Use

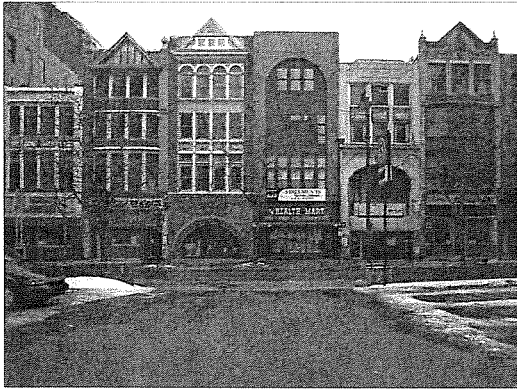
Front view showing floor alignment

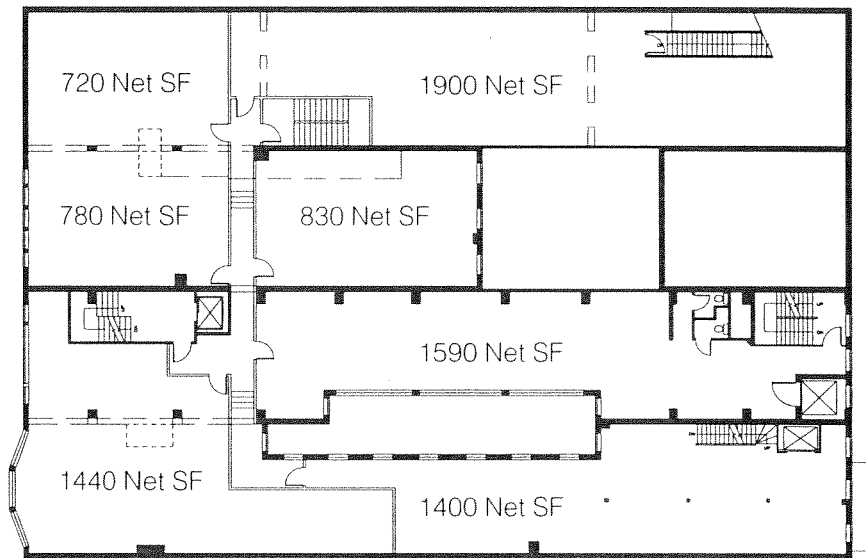
Typical Floor Plan

Proposed New Use

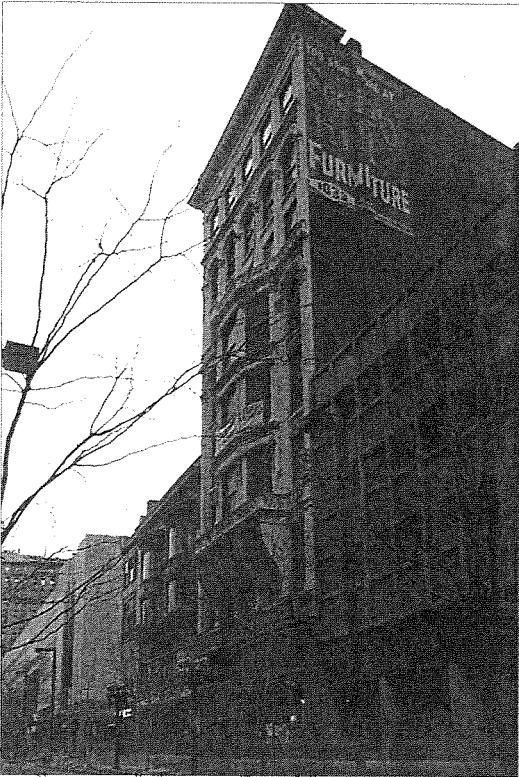
*View to east showing adjacent vacant buildings*

A towering commercial structure in its day, Society Hill Furniture reaches eight stories on the north side of Chestnut Street. The building occupies a strategic site among of a series of older structures suffering from a high vacancy rates. To the east, the '50s-era Mercantile Library is vacant and even a Rite-Aid nearby is deserted; to the west, the upper levels of buildings are sealed off and dormant. Because of its location, visibility, and size, a commercial or residential reuse of the 39,350 sf building would have a significant positive impact on the neighborhood.
